**PENENTUAN KAWASAN BENCANA BERDASARKAN PENDEKATAN *MULTIFACTOR*  
(DESAUNETTES, KARAKTER DAN KETEKNIKAN BATUAN) PADA RUNTUHAN  
TUBUH GUNUNG API MANGLAYANG, WEST JAVA, INDONESIA**

*DETERMINATION OF DISASTER-PRONE AREAS BASED ON A MULTIFACTOR APPROACH  
(DESAUNETTES, ROCK CHARACTERISTICS AND ENGINEERING) ON THE MANGLAYANG  
CATASTROPHE VOLCANO EDIFICE, WEST JAVA, INDONESIA*

**Putu Ayu Andhira\*<sup>1</sup>, Faishal Aziz<sup>1</sup>, Muhammad Khozi<sup>1</sup>, Teuku Yan Waliana Muda  
Iskandarsyah<sup>1</sup>, Johanes Hutabarat<sup>1</sup>, Hendarmawan<sup>1</sup>**

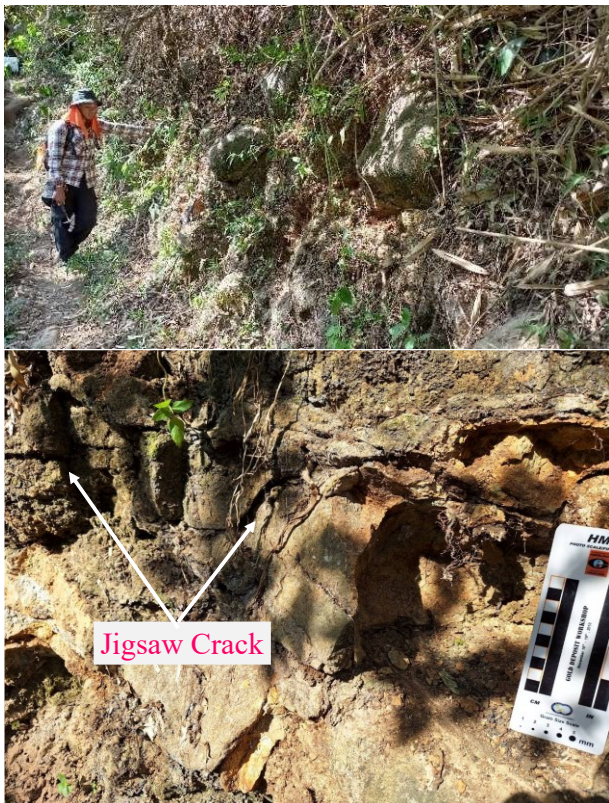
Several outcrops exhibit structural and textural characteristics that are consistent with a volcanic sector collapse and are interpreted as debris avalanche deposits (**Figure 5**). The debris avalanche deposits observed within the study area are characterized by volcanic breccia containing fragmented lithic clasts exhibiting jigsaw-crack (**Figure 6 & 7**). These clasts are supported by a matrix ranging from very fine-grained volcanic ash to lapilli-sized material. In terms of sorting, the deposits are very poorly sorted, with randomly distributed grain sizes, and exhibit a massive, structureless, and chaotic fabric.

**Figure 6.** Observation Station ZI-4007 showing a debris avalanche deposit characterized by a jigsaw-crack structure.

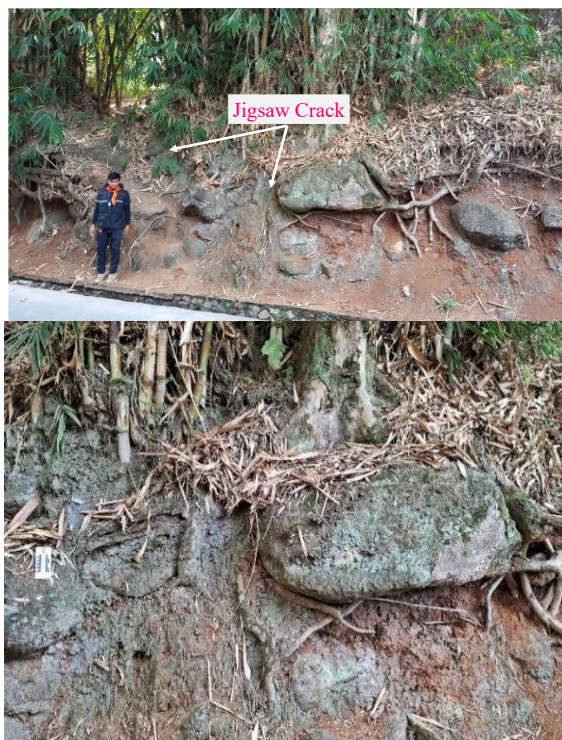
**Figure 7.** Observation Station ZI-2002 showing a debris avalanche deposit characterized by a jigsaw-crack structure.
